# Wildfires & Debris Flows, Oh my!

Mike Conway – Ann Youberg

# Debris flow — concrete slurry: the perfect analog

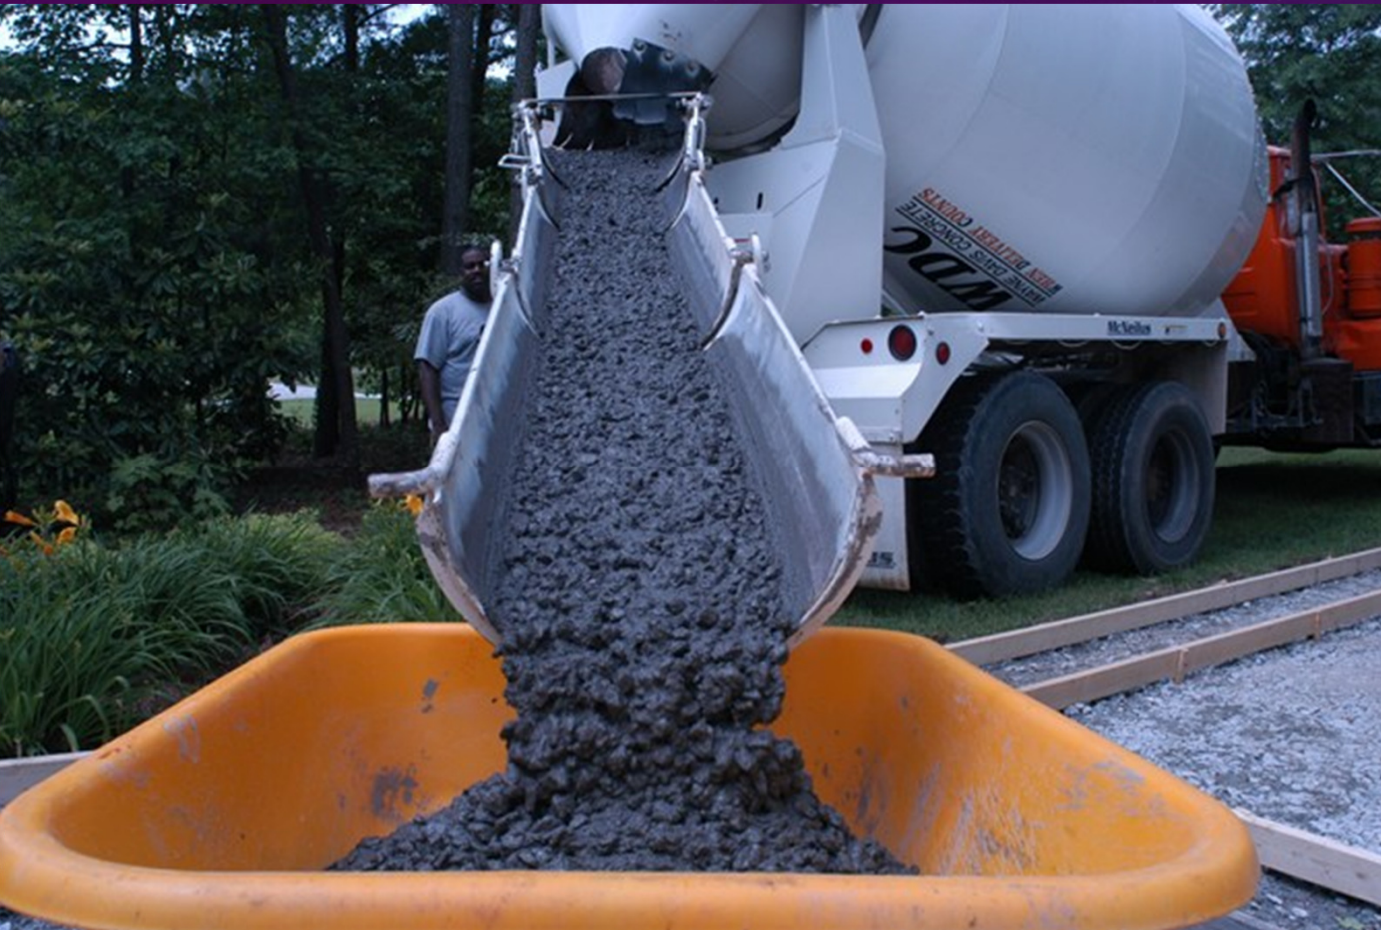
- 60%+ by volume - loose mud, sand, soil, & rock - water and air that travels downslope.
- solids > water (viscous slurry)
- > ½ solids in the mass larger than sand grains;
- Speed – slow to fast up to 100 mph

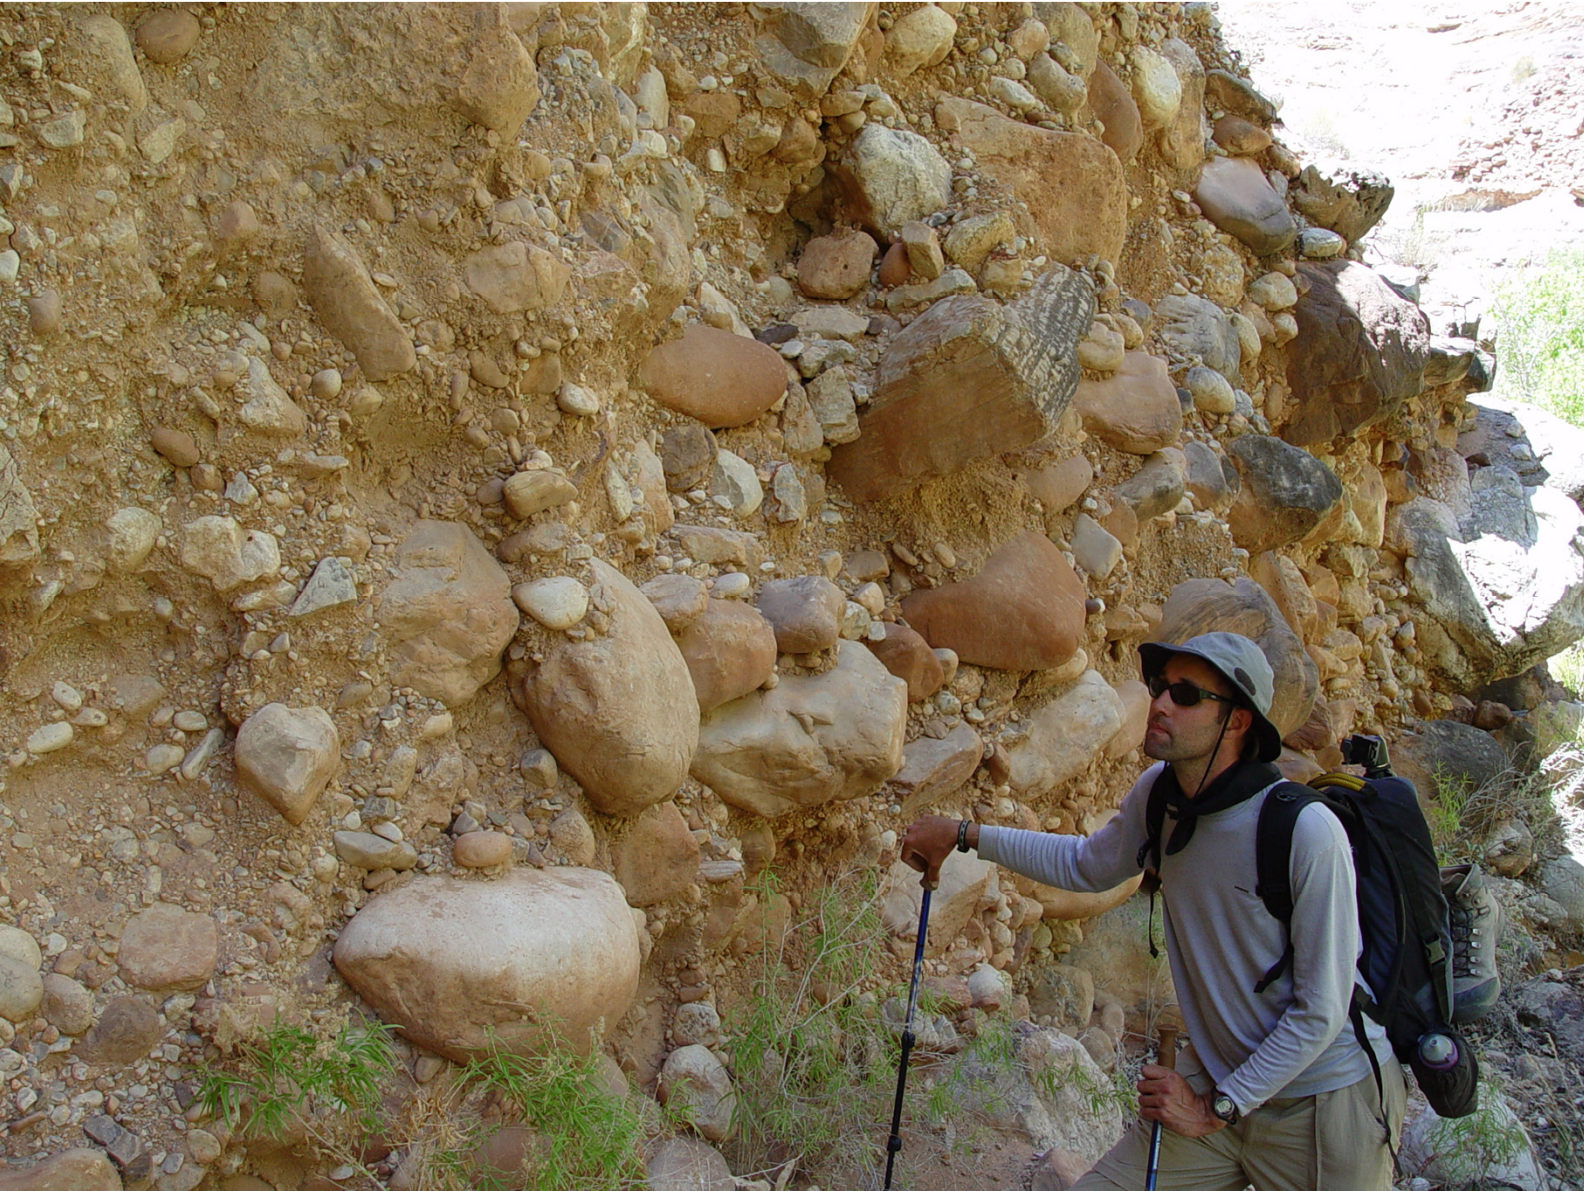
Debris flow  
deposit  
Grand Canyon, AZ

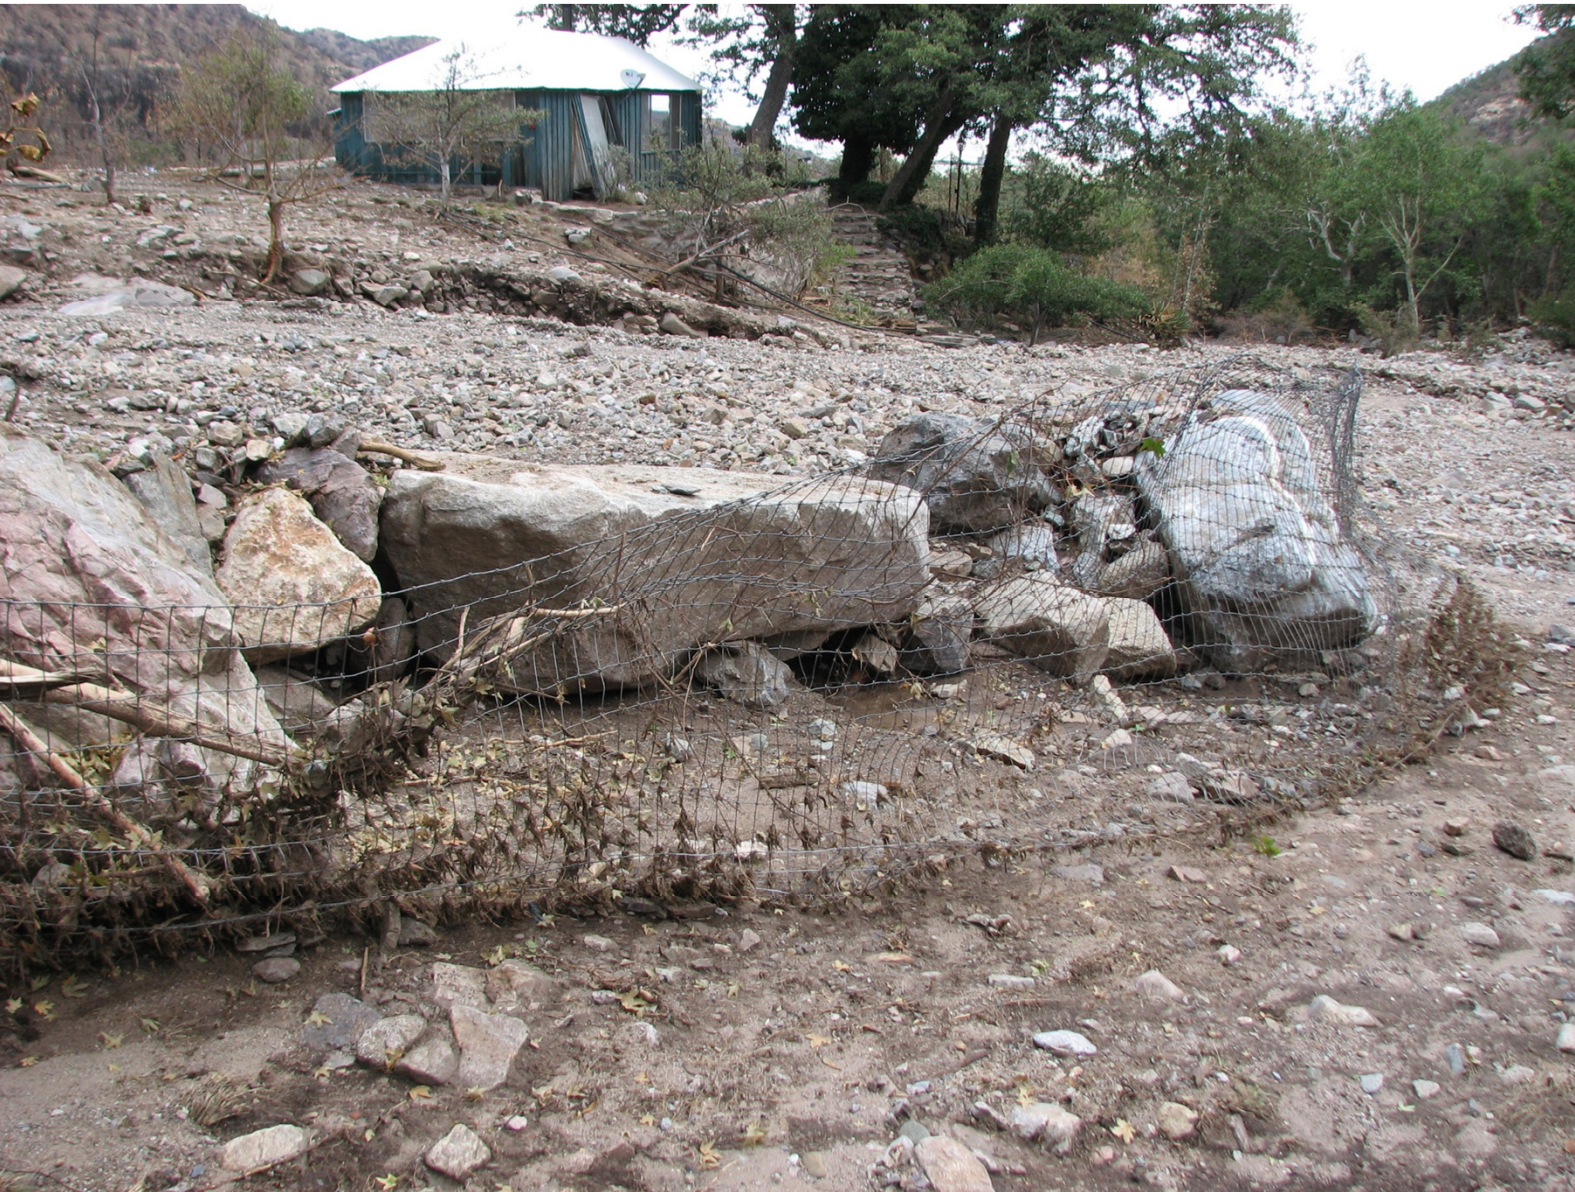
2011 Monument Fire  
Miller Canyon/Beatty's  
Debris-flow deposits in  
Foreground, flood damaged  
Cabin in background.

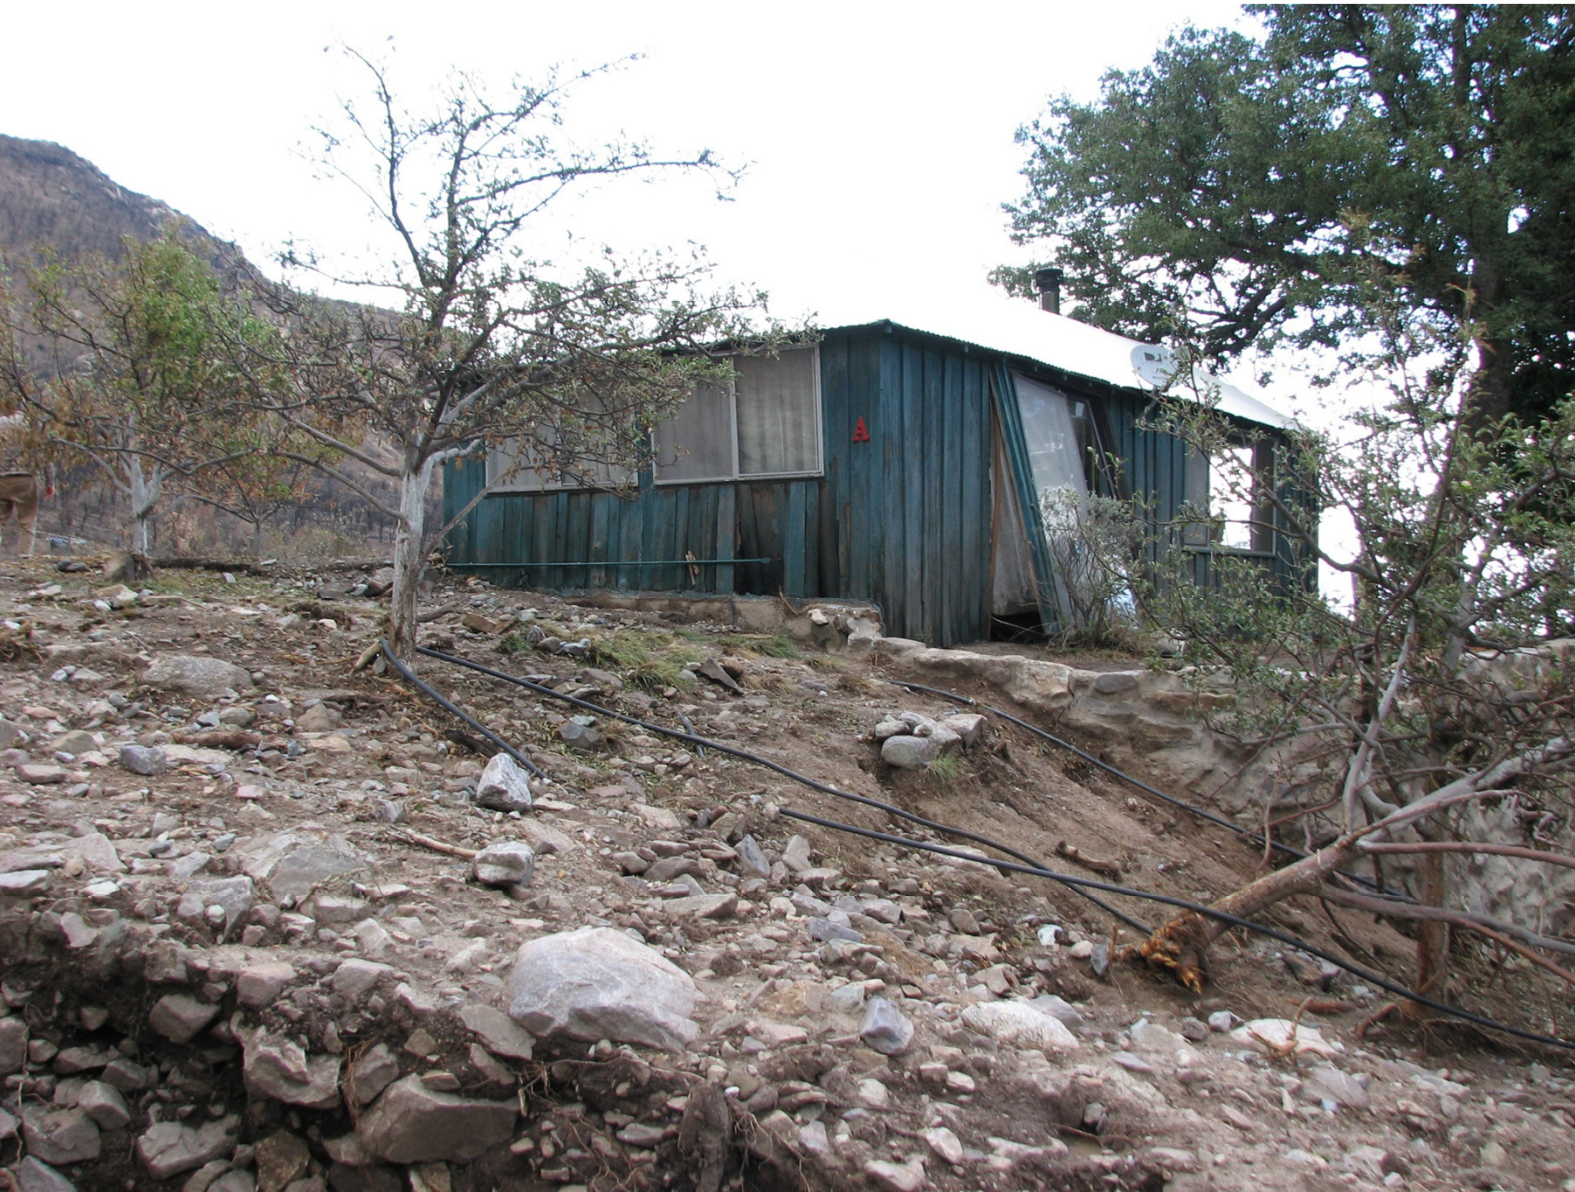
2011 Monument Fire  
Miller Canyon/Beatty's  
Flood-damaged cabin.  
2-yr 60-min storm

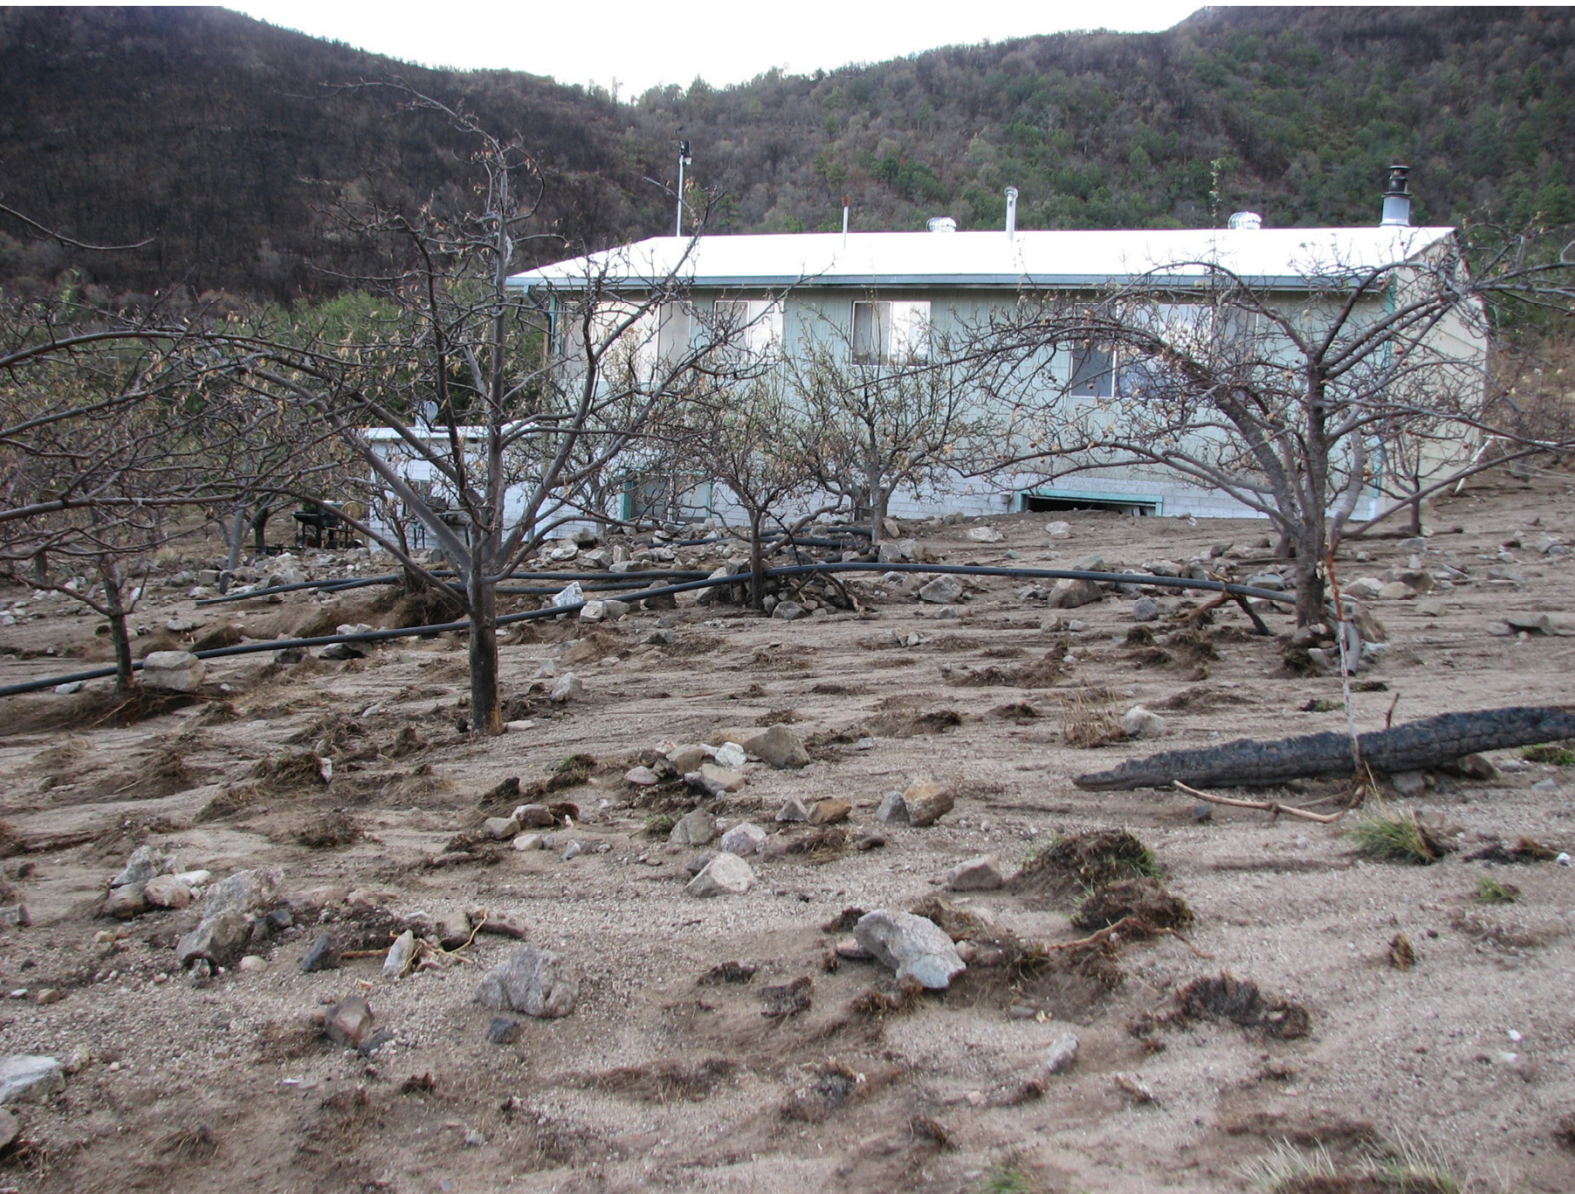
2011 Monument Fire  
Miller Canyon/Beatty's  
Grus from this tiny drainage  
put a slug of sediment in and  
around this cabin. Not clear if  
debris flow or  
hyperconcentrated.  
2-yr 60-min storm

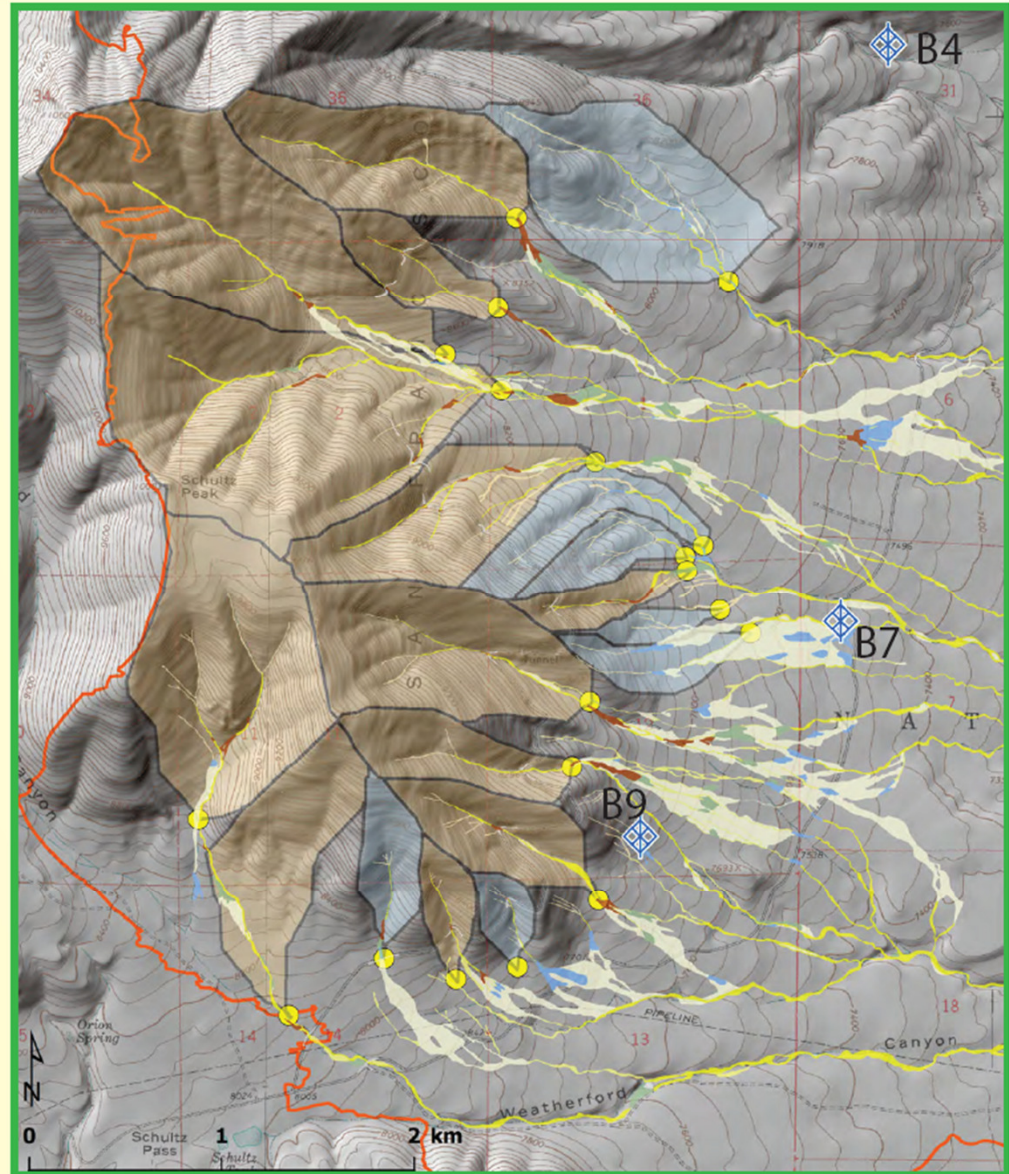
Schultz Fire Basins ( $n = 19$ ) with  
outlets based on flood and debris flow  
deposit locations at or just  
below the base of the steep, upper  
slopes.

Opportunities for flooding &  
debris flows abound (basins  
 $n=19$ )

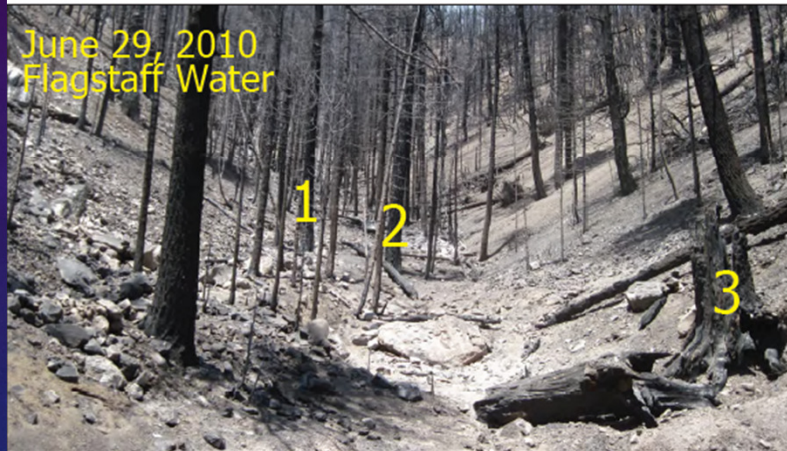
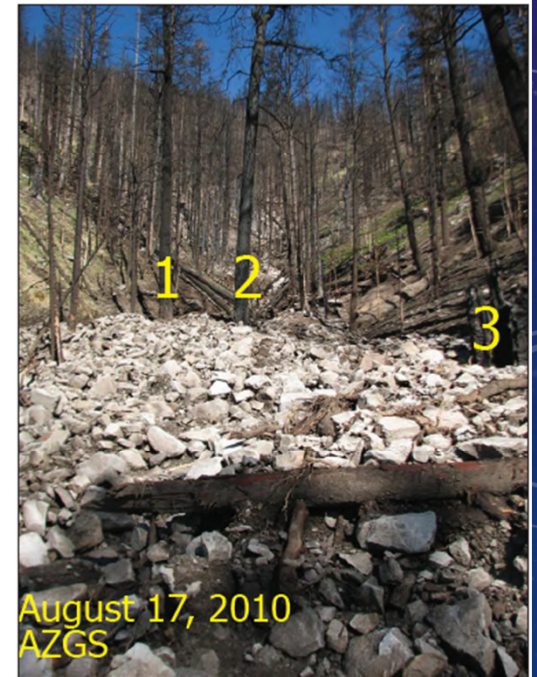
Basin condition in the Schultz Fire  
burned area: post-fire, pre-storm  
(above), post-storms (right).  
(Numbers match trees between  
photos)

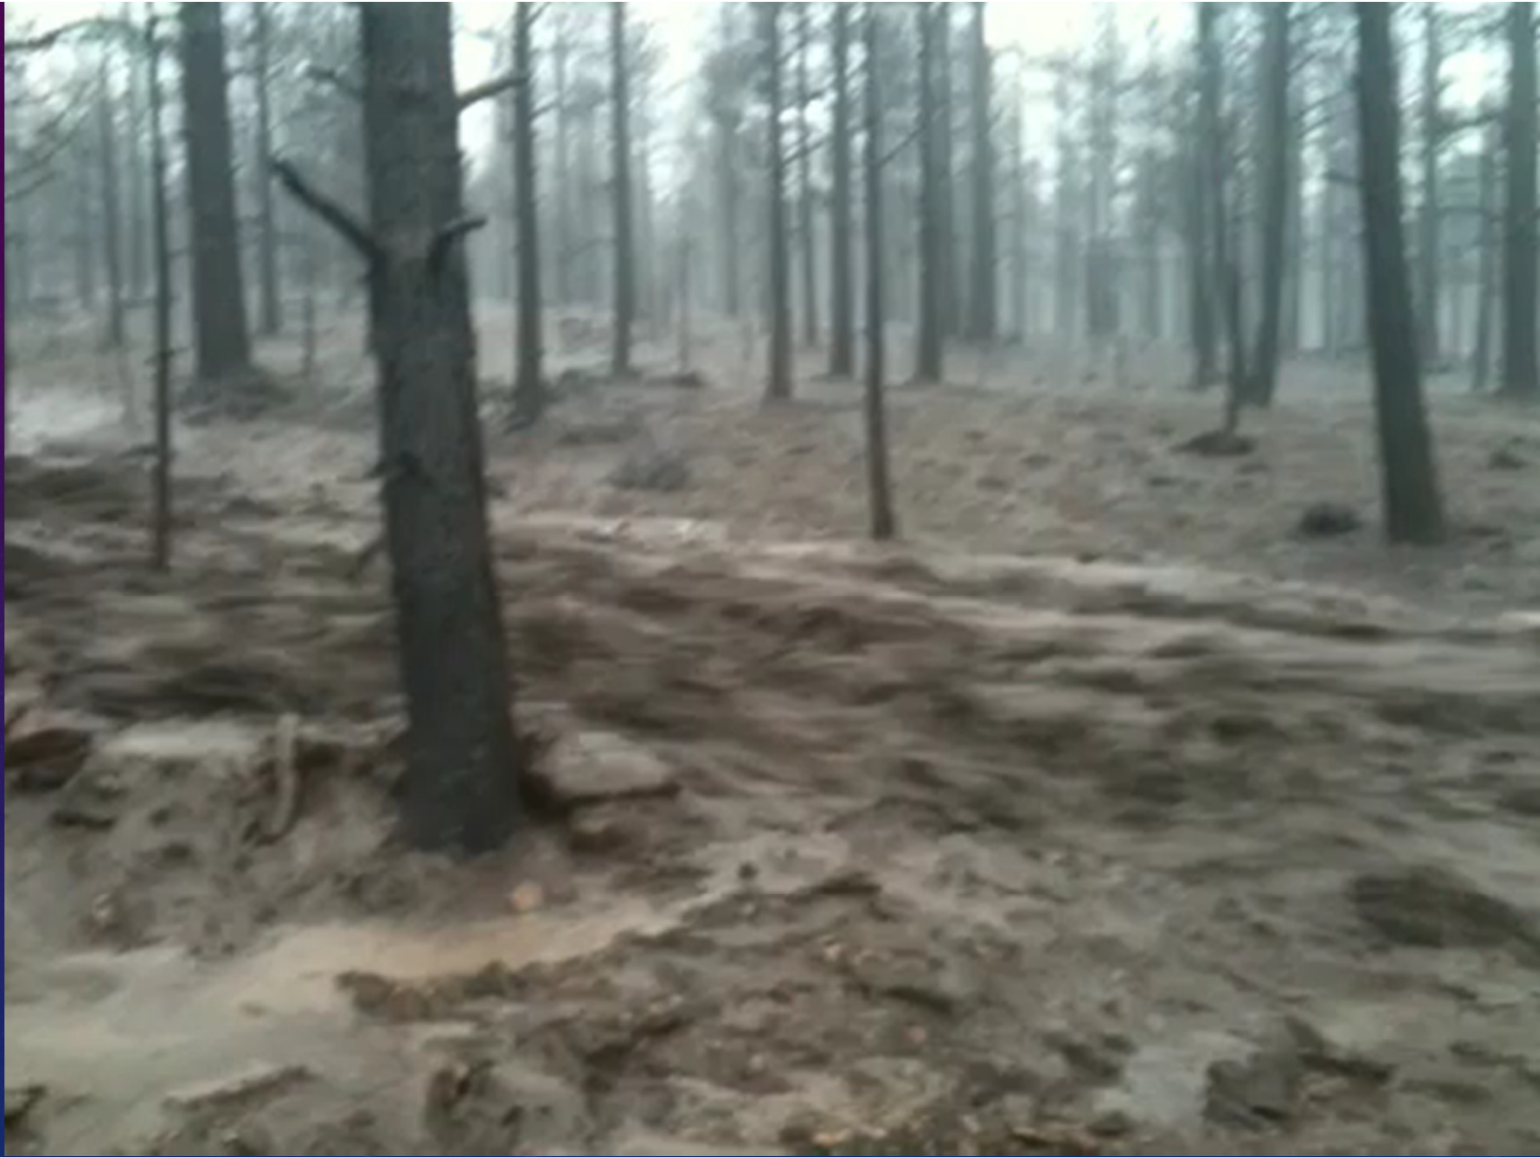
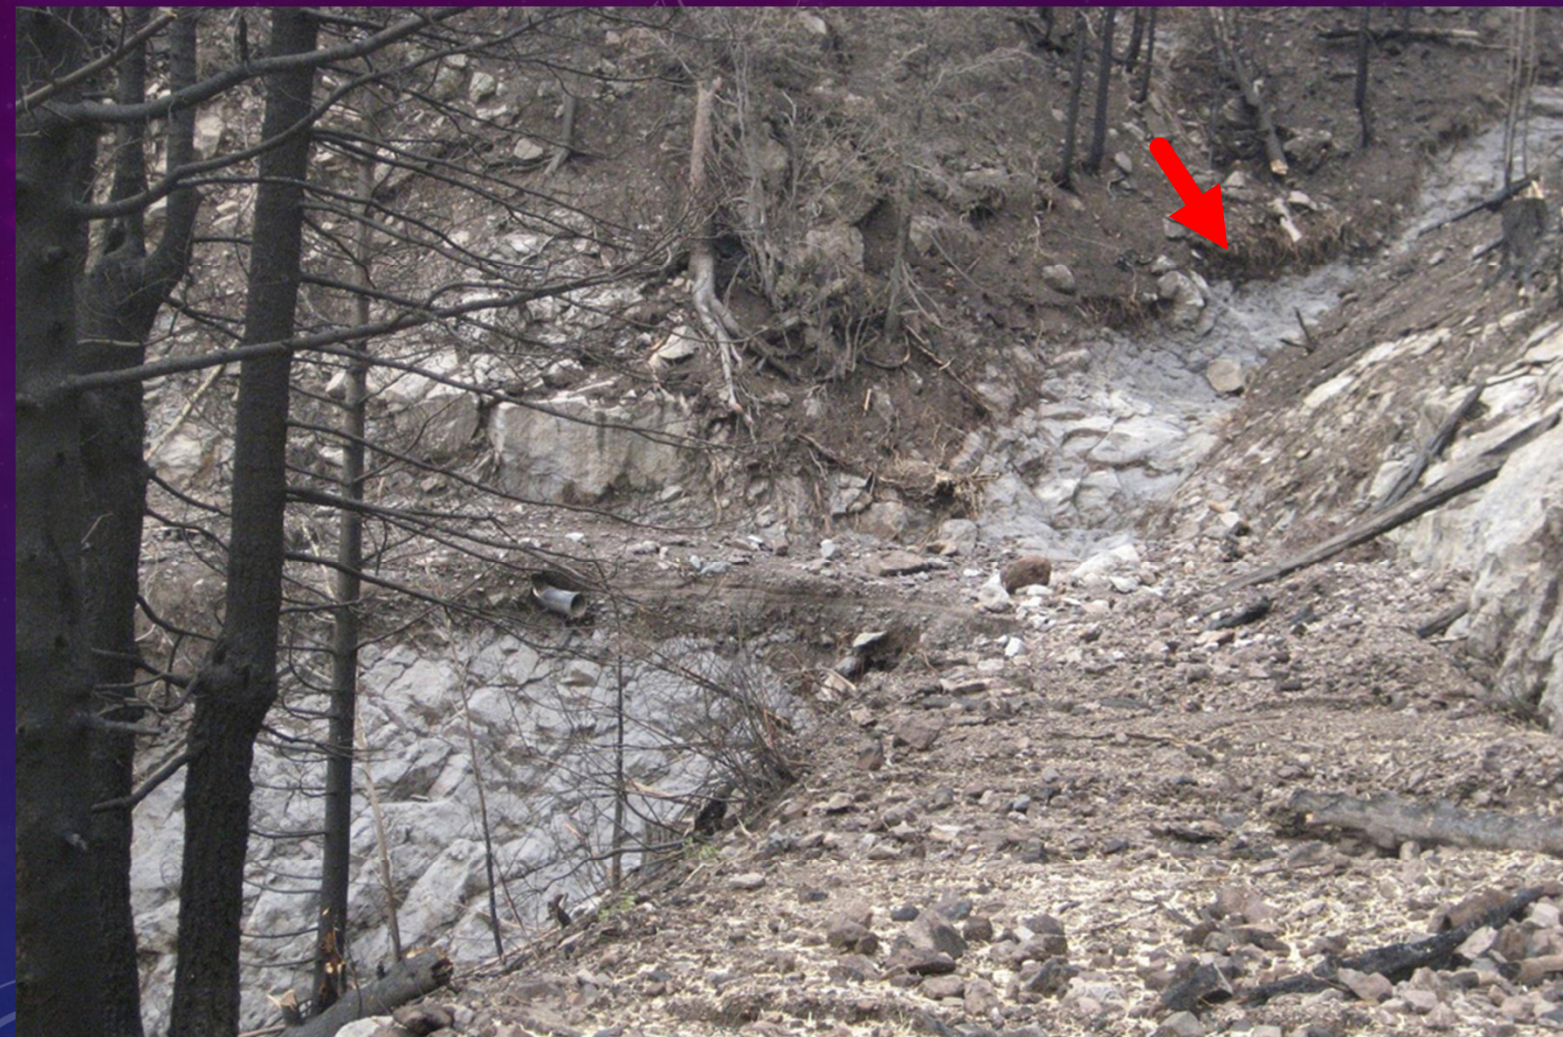
July 25, 2010:  
San Francisco Peaks  
FR146 - drainage  
where the waterline  
was severed and  
removed by debris  
flows on July 20th.

Roadbed demolished  
by the August 16th  
debris flows.

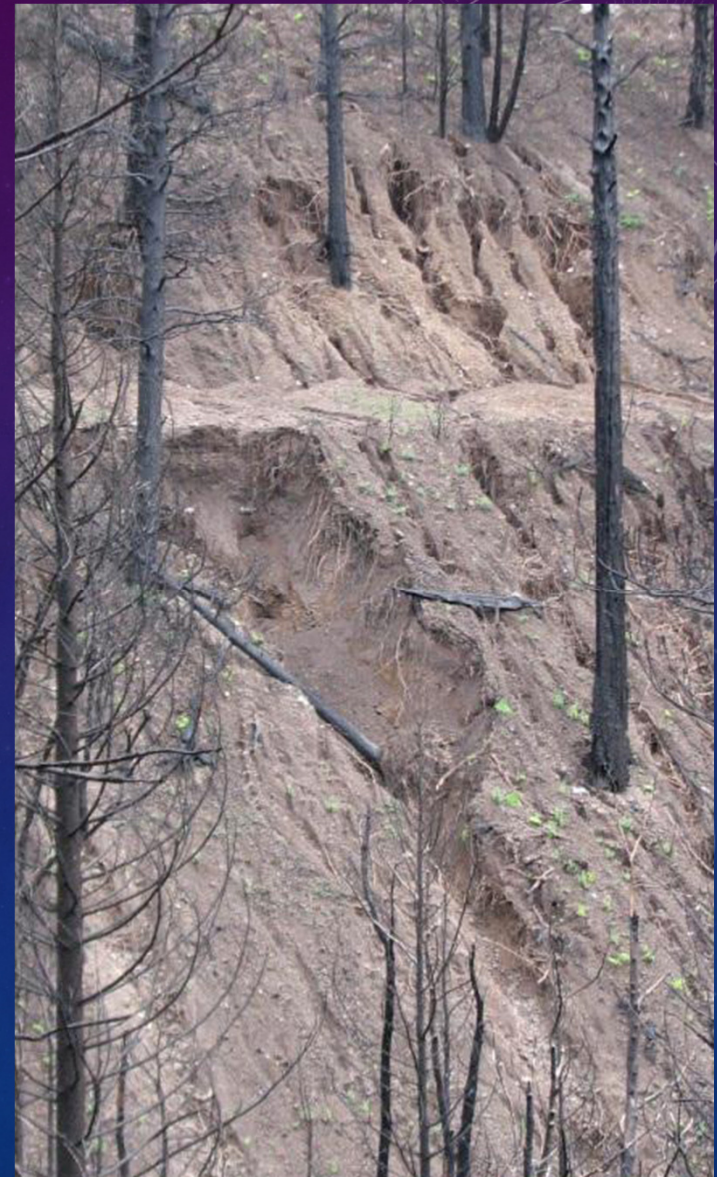
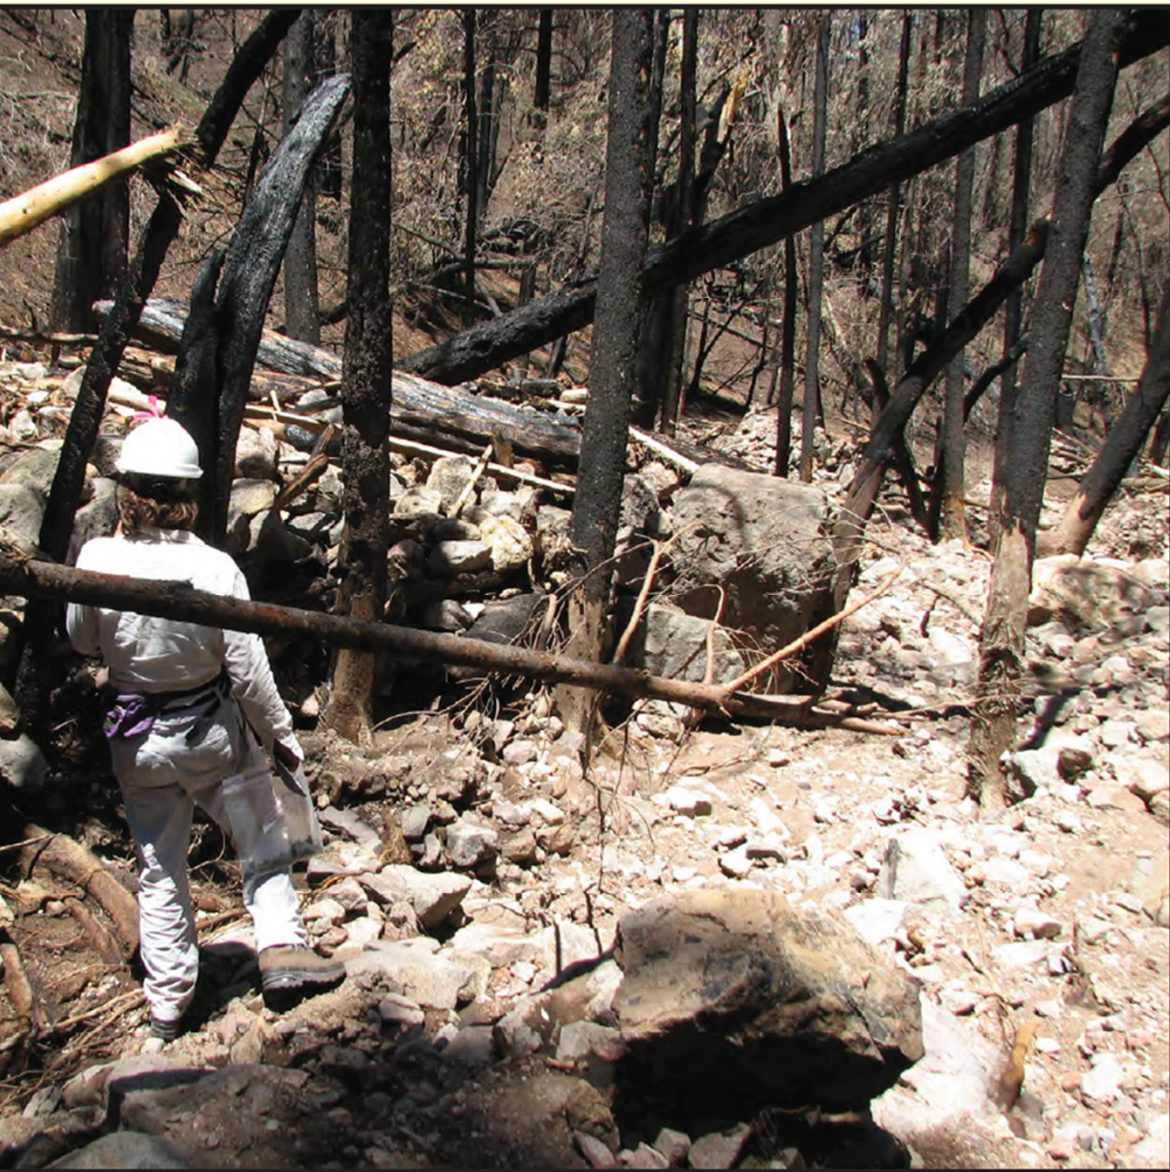
Hillslope erosion along FR146, San Francisco Peaks.  
August 17, 2010. Photo: A. Youberg, AZGS.

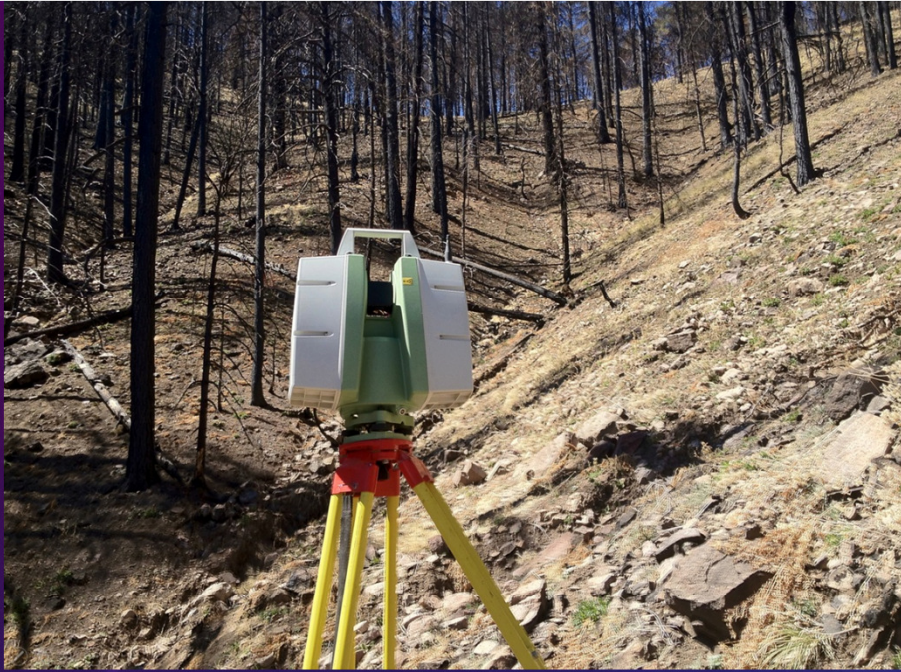
0.05 m DEM slopeshade June 21, 2011 then July 18, 2011

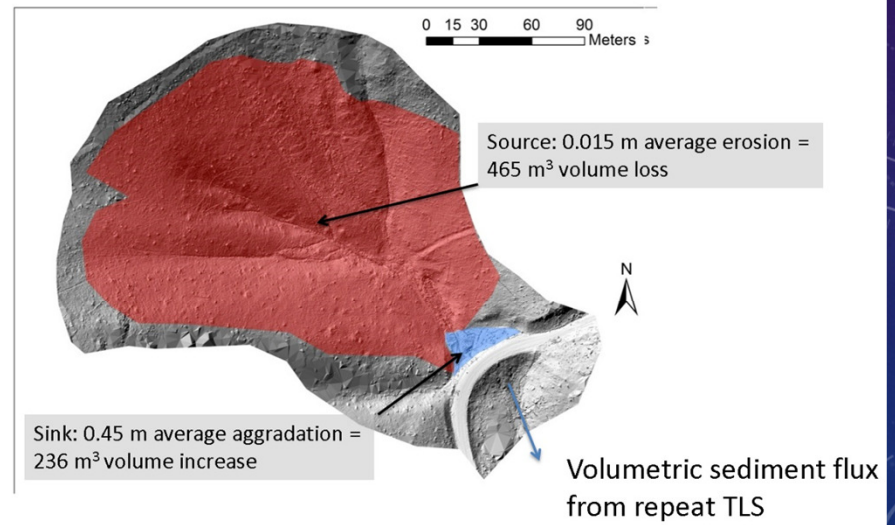
Terrestrial (lasar) Lidar Scanning  
- Monitoring landscape changes

Volumetric sediment flux

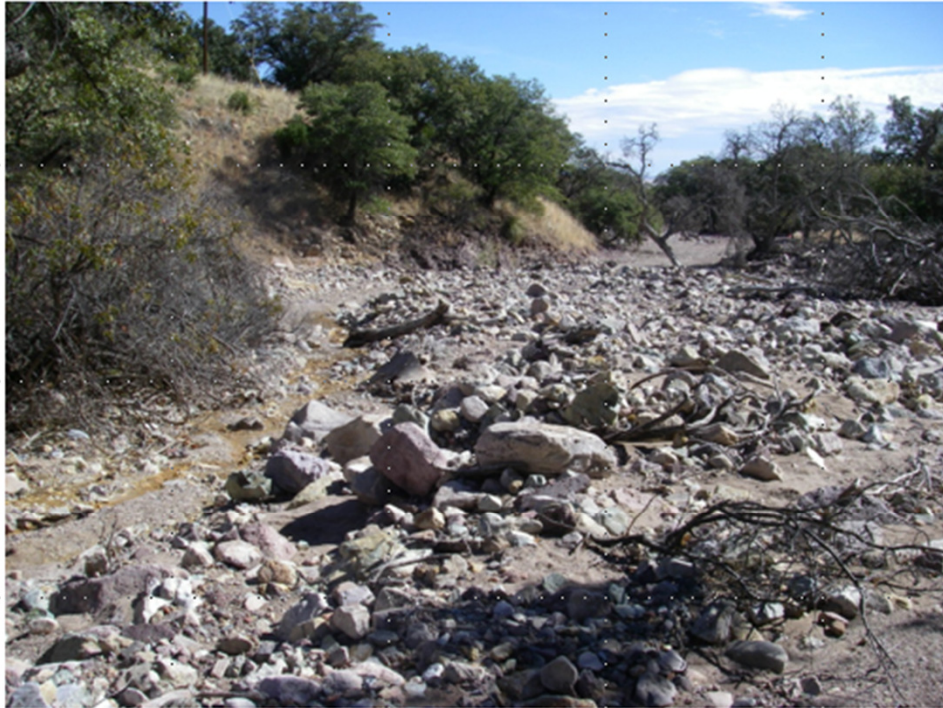
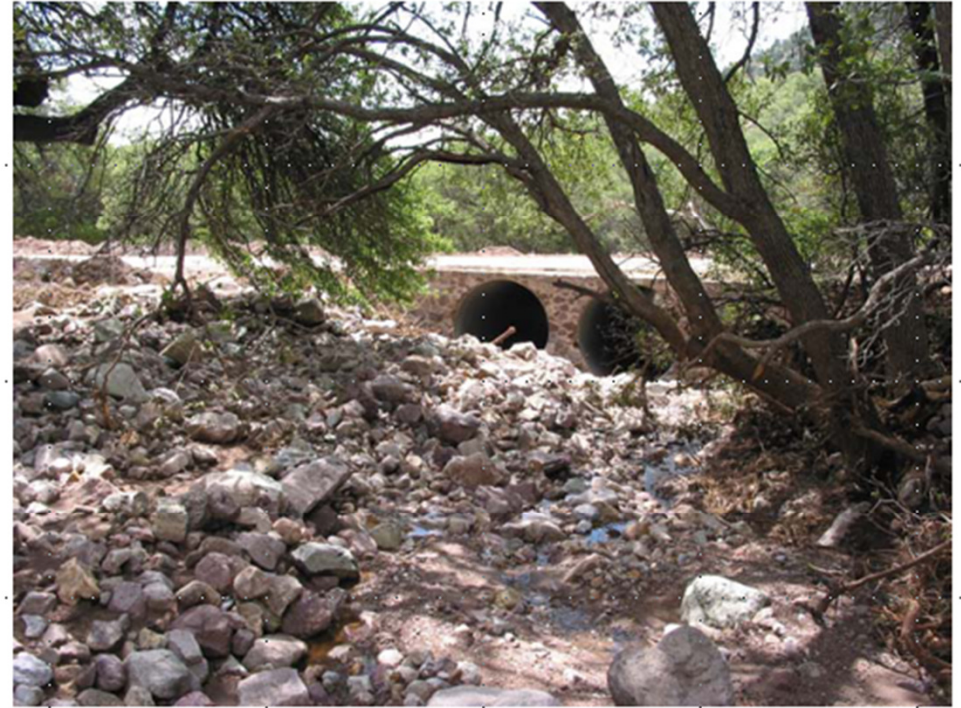
*Debris in channel near Visitor's Center looking downstream from well site and downstream at 9 ft culverts*

Montezuma Creek – Coronado National forest  
Disturbed by fire in 1988, 2006, 2011.
